PIT LAKE TREATMENT AT LES MINES SELBAIE

Abstract

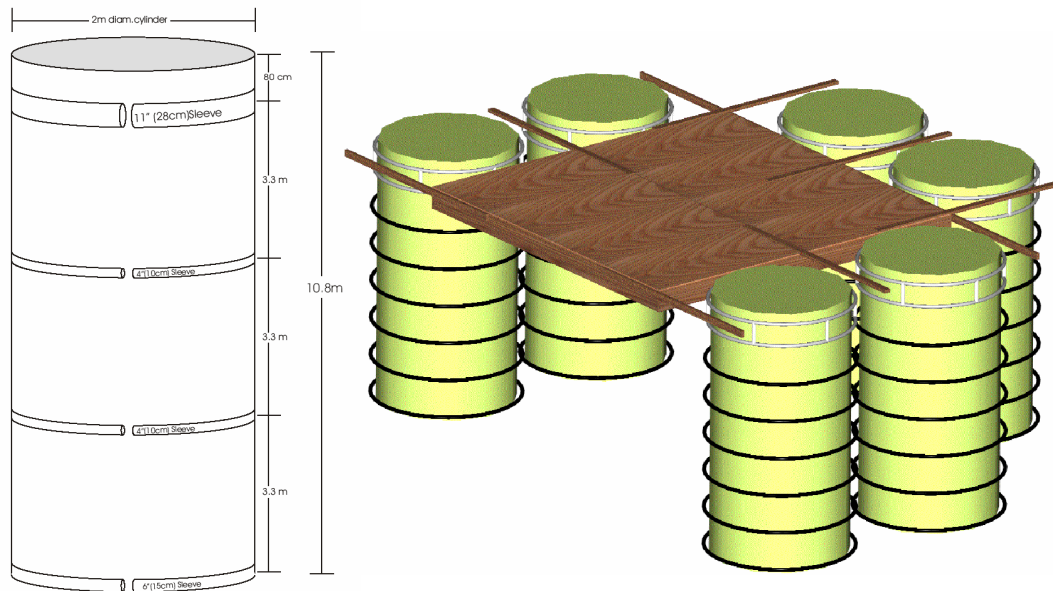
The laboratory tests were followed by limnocorral experiments in the field. Limnocorrals are experimental enclosures, which are open at the top and bottom and isolate a portion of the water column from lateral mixing within the lake. The limnocorrals used in this project were 2 m in diameter and 10 m in depth (see Figure 1). Limnocorrals were designed to isolate the mixed surface layer (epilimnion), which according to previously collected data was in the 4 to 6 m depth range.

A 16' x 16' raft with six bays for attaching the limnocorrals was constructed and deployed at the site. Limnocorrals were fabricated from polyethylene tarp material with support rings (1/2" diameter plastic pipe) inserted into sleeves every two metres along the tube to ensure the tube maintained a cylindrical shape (Figure 1). Floatation was provided by foam cylinders inserted into a sleeve at the top of the tubes. A collar extended approximately 30 cm above the lake surface to reduce waves and spray from outside the limnocorrals entering the isolated water column. The bottom of the tube was weighted with sand-filled plastic pipe. The contained water volume was about 31 m³.

Figure 1: Limnocorral Dimensions and Design of Raft

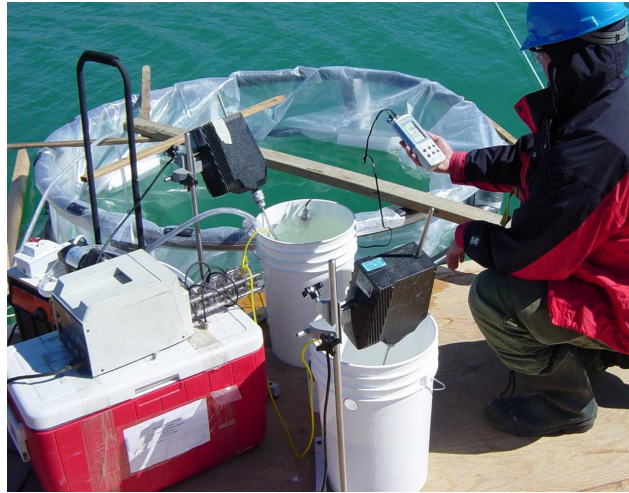
The two recirculation tests to treat Limnocorrals #2 and #3 took 5 to 6 days respectively. Recirculation treatment was effected with a 10 L/min diaphragm pump, conveying untreated water to a 20-L pail where pH was controlled by lime slurry addition (see Figure 2). A pH probe was inserted near the overflow of the treatment bucket and monitored regularly to ensure continuous treatment to the setpoint pH. Lime addition was controlled using a variable-speed peristaltic pump transferring lime slurry obtained from the Selbaie Lime Plant. Both the lime slurry and the treatment buckets were continuously stirred using agitators. Treatment was conducted for 6 to 8 hours per day because operators could not monitor the treatment system at night and during meal times.

Figure 2: Recirculation Treatment of Limnocorral #2

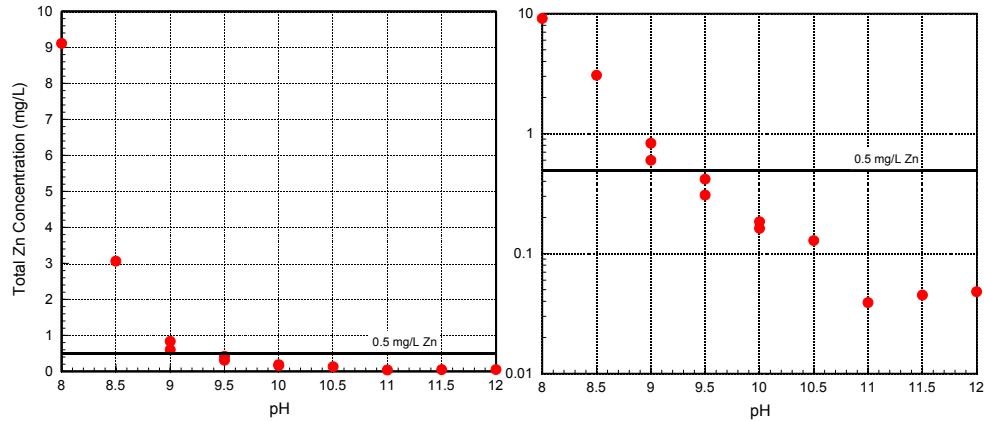
The treatment goal was to attain a total Zn concentration of less than 0.5 mg/L. Figure 3 shows the lime treatment results on both a linear and log scale for better resolution at low concentrations. Duplicated tests show excellent repeatability as illustrated by the points at pH values of 9, 9.5, and 10. Overall, these results indicate that the target concentration of 0.5 mg/L of total Zn is attained at a pH of 9.5. Also evident is a significant improvement when increasing the pH to 10.0, with further minor improvement when raising the pH to 11 or higher.

Given these results, a pH of 10 was selected as setpoint for further test work. Reason is that the Zn concentration when treating at pH 9.5 was only marginally below the target of 0.5 mg/L by 0.1 mg/L. By adding a little more lime and treating to a pH of 10, the final Zn concentrations were below 0.2 mg/L. According to Figure 4, the lime consumption was actually lower for the pH 10 setpoint but this is attributed to experimental error. The difference between the two lime consumption measurements was 0.03 g/L and the balance used to measure the lime consumption had a precision of 0.01 g/L. The logarithmic graph clearly shows a linear relationship between lime consumption and pH, except that the pH 9.5 value is an outlier.

Figure 3: Zn Concentrations with Respect to pH for Lime Addition Tests

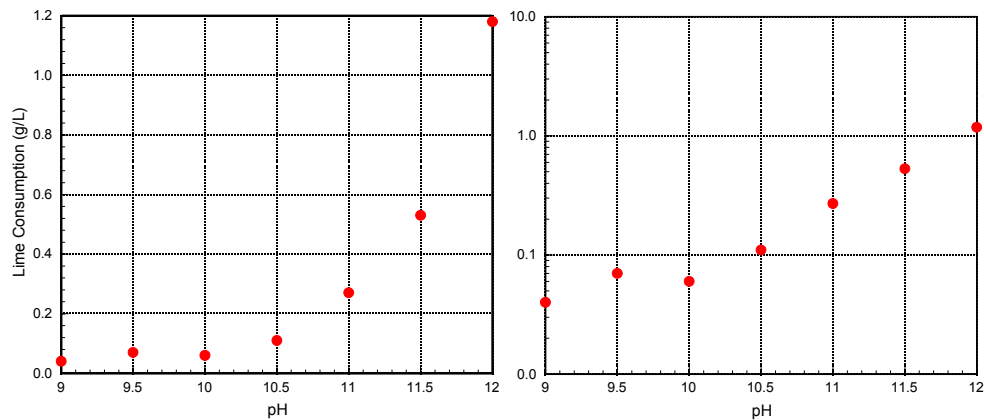
Figure 4: Lime Consumption with Respect to pH

The treatment system was installed in late summer of 2005 and commissioned on September 15th. The treatment objective was to gradually inject 2,000 tonnes of quicklime while ensuring proper dissolution efficiency. To promote dissolution while treating quickly, the lime injection rate was to maintain a pH between 11.5 and 12 at the discharge of the piping. A higher pH would decrease the lime dissolution efficiency and result in significant settling of unreacted lime particles. A pH of less than 11.5 would reduce the feed rate of lime and prolong the required time for complete treatment. According to the laboratory tests (Figure 4) this pH range represented a hydrated lime injection rate between about 0.5 and 1.2 g/L.

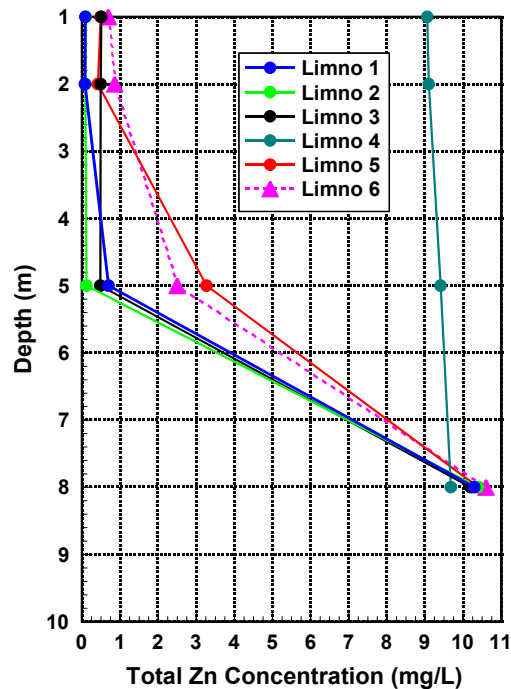
Figure 5 shows the initial profiles taken after the primary treatment in each of the 5 limnocorrals that were treated (limnocorral #4 was kept as a control). Surface treatment

in limnocorral #1 proved that surface lime addition can successfully treat the epilimnion (warm upper layer of the lake). The treatment in this limnocorral did not successfully penetrate the thermocline as the sample taken from a 5-m depth did not meet the 0.5 mg/L target. These results agreed with surface treatment to a pH of 9.5 in limnocorrals 5 and 6, which resulted in Zn concentrations near but not below the target of 0.5 mg/L at 1 and 2-m depths. The 5-m depth was above 2 mg/L for both limnocorrals, thus showing that surface treatment does not penetrate the thermocline.

The results from Limnocorral #2 showed that recirculation and discharge at surface can not only treat the epilimnion but also penetrate the thermocline as the Zn concentration at the 5-m depth was 0.12 mg/L. Unfortunately, it was not possible to properly ascertain the treatment efficiency at depth because the lake hypolimnion (deep cool layer of water) mixed with the lower portion of the bottomless limnocorrals. Limnocorrals were

In Limnocorral #3, treatment was accomplished by drawing water at the surface, liming it, and injecting it at depth. Due to the mixing at the bottom, this treatment method was unsuccessful in the limnocorral. Measurements taken during treatment nevertheless indicated that injecting treated water at depth can quickly increase the pH up to the bottom of the thermocline.

Figure 5: Zn Profiles in Limnocorrals Following Treatment

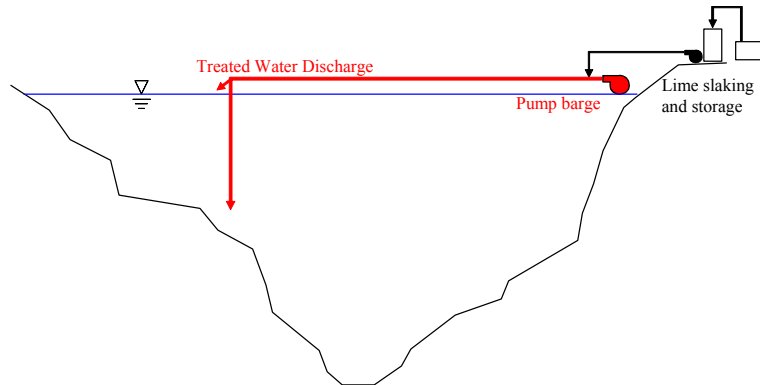
Based on these findings, EnvirAubé proposed the conceptual design of a recirculating treatment system to batch treat the entire 22+ Mm³ of water (see Figure 6). The conservative lime consumption estimate used an expected lime efficiency in the order of 75%.

The water pumping system consisted of two submersible pumps of 1,300 and 1,400 m³/h capacity for water recirculation from the surface (2 m depth) to depth (40 m depth). These pumps were supported by a barge near the existing access ramp. Lime slurry was injected at the pump discharge into the 18" HDPE pipes that conveyed the treated water to the South and North discharge rafts, positioned respectively 330 m and 480 m away. The pipes themselves floated either just below the water surface or up to 2" above during operation.

Figure 6: Conceptual Representation of the Treatment System (cross-section)

SNC-Lavalin Inc. completed the detailed design, commissioning, and operation of the pit lake treatment system. It consisted of a portable batch slaking system, agitators, and two slurry pumps (all rented) plus a lime slurry storage tank, and two water recirculating systems. Conceptual drawings are shown in figures 6 and 7 for the cross-sectional and plan views respectively. Figure 8 shows a photo of the treatment system with identification of the key elements.

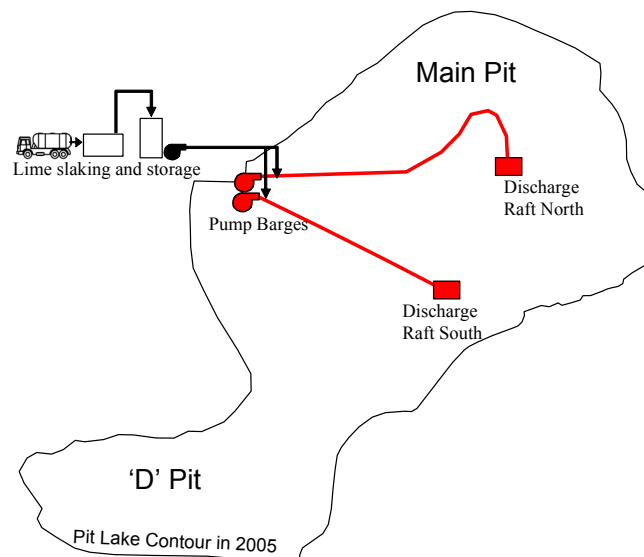
Figure 7: Conceptual Representation of the Treatment System (plan view)

All sampling campaigns were done at multiple locations in the pit. This was important to ensure homogeneous treatment, particularly because the “D” Pit is partially separated from the Main Pit where treatment was accomplished (see Figure 7). Profiles taken at different locations were always reasonably similar during treatment and essentially the same before and after treatment. For this reason, only the results from the central location of the Main Pit are described here.

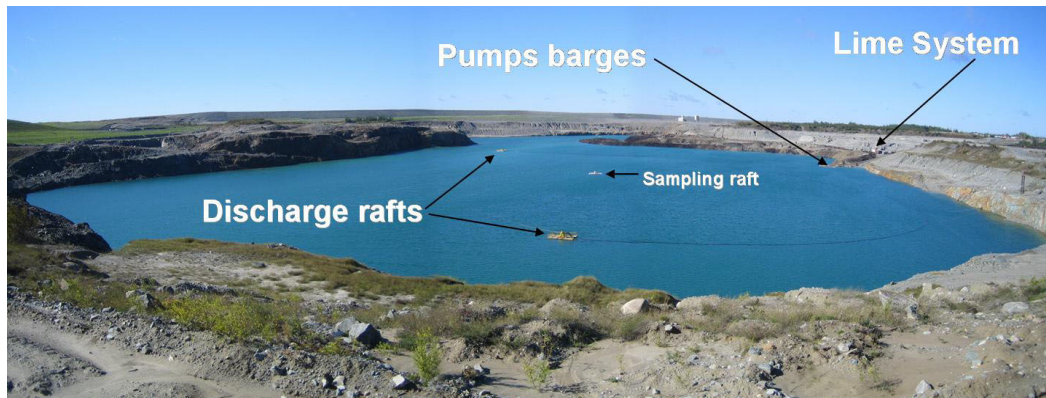
Figure 8: Photo of Treatment System soon after Commissioning

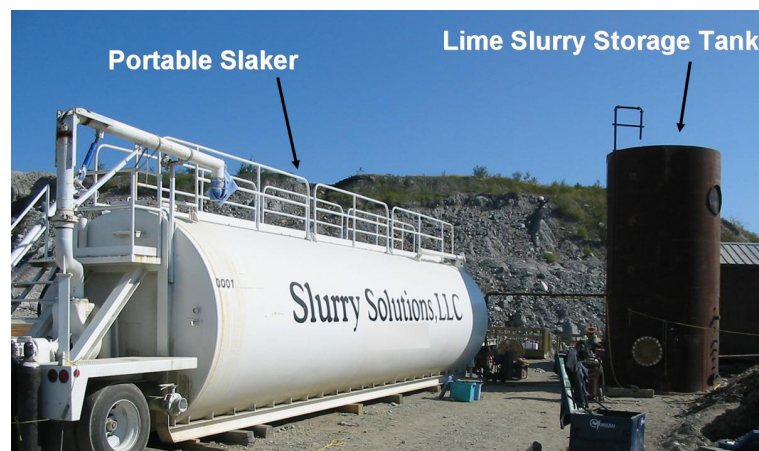
The lime system (including portable slaker, lime storage tank, and pumps) was installed near the pit ramp on a solid bed of crushed rock, as shown in Figure 9. The two submersible pumps were installed on a floating barge, accessed by a ramp from the shore. The most challenging phase was the installation of the 40-m steel downpipes. As the mining benches below water were 10 m by 10 m, it was necessary to float the steel downpipes out before bringing them vertical. The pipes were capped at one end to enable them to float. An excavator was used to guide the pipe out before attaching it to the discharge raft and getting it vertical. Figure 10 shows the excavator gently pushing the out the downpipe with the sealed end toward the viewer and the diffuser end submerged. Next to the downpipe is half the pump barge with the pump piping already attached. The two halves of the pump barge were attached following deployment.

Figure 9: Lime Slaker and Slurry Storage Tank

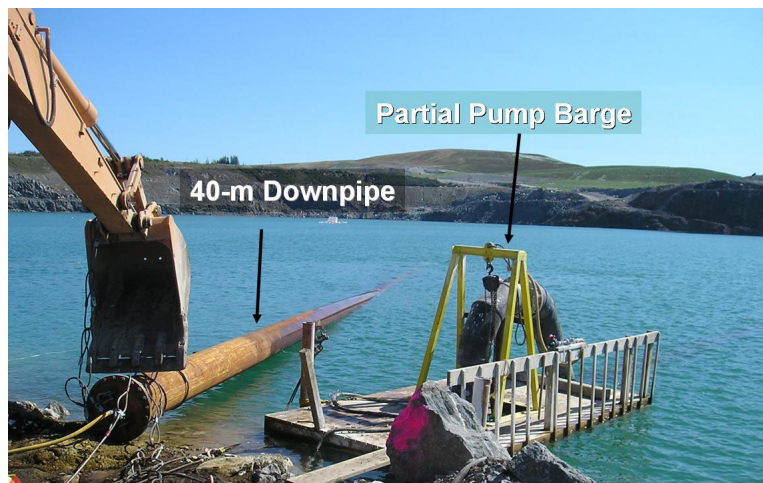
Following the use of the excavator, the downpipe was moved out into the pit lake by attaching it to the discharge raft and pulling it out with a boat. To bring it vertical, a valve installed at the sealed end was opened to allow air out and water to enter from below. Once it was vertical, the downpipe was attached to the raft and fully deployed.

Figure 10: Deployment of Downpipe

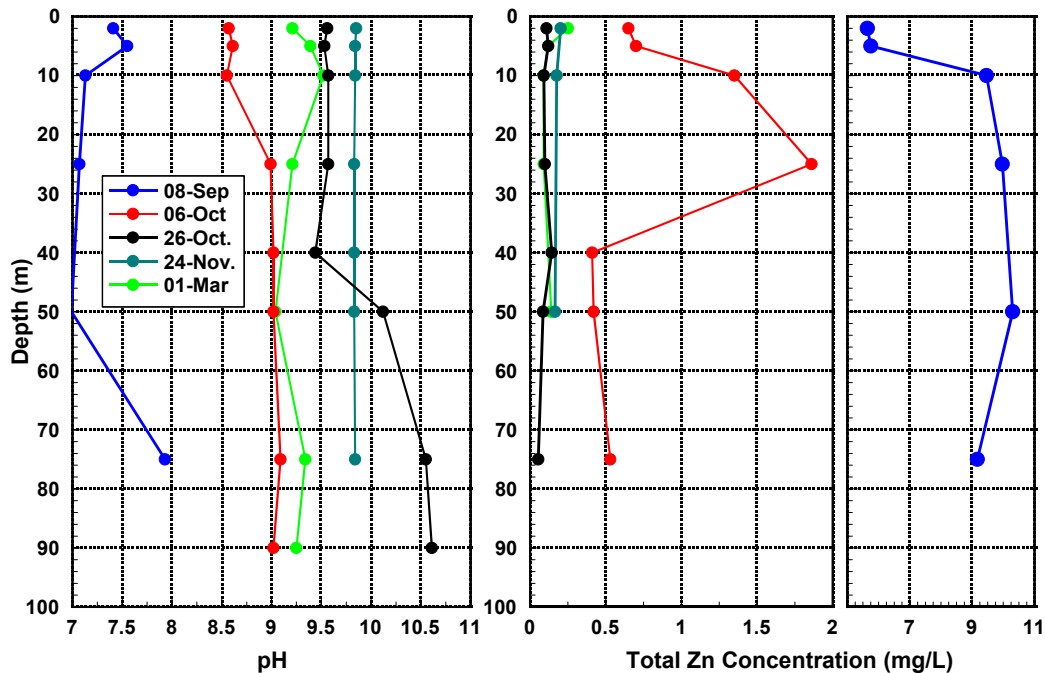
Figure 11 shows some of the pH and Zn profiles measured in the pit lake during and following treatment. As shown in Table 2, the initial average pH was 7.2. The pH values quickly increased during operation. Due to weather conditions, it was not possible to complete the profiling immediately following treatment, which is why the final pH measurement was taken 19 days after treatment was discontinued. It is likely that the pH had reached the target of 10.0 as in that 19-day interval there had been significant precipitation which may have decreased pH. On October 26, 10 days before the end of treatment, there is a clear increase in pH below the 40-m injection depth. This is caused by the partial settling of limed water due to its’ higher density. At this time the water column was of a relatively uniform temperature of 7°C. Earlier in the treatment campaign, the water being injected had a temperature above 10°C while the water at depth was at 6°C. With initial temperatures, the treated water did not noticeably settle. The surface temperatures decreased naturally due to the decreased air temperatures, but the treatment system itself equalised the temperatures quickly due to the high rate of surface water injection at depth.

The right side of Figure 11 shows the Zn concentration profiles measured at different times in the pit lake. The graph is divided to better show the initial total Zn concentrations (scale of 5 to 11 mg/L) as well as the eventual decrease in concentrations (scale of 0 to 2 mg/L). The initial Zn concentrations were near 10 mg/L at depth and 6 mg/L at surface. The Zn concentrations decreased rapidly and the expected target of 0.2

mg/L was met after only 35 days of treatment. All of the profiles from October 26 onward are not discernable as they are all below 0.25 mg/L.

Figure 11: Profiles of pH and Total Zn in Pit Lake
